PCBs in Open Applications: Part A: Sealants/caulks in construction

Dr. Roland Weber

POPs Environmental Consulting,
73527 Schwäbisch Gmünd, Germany

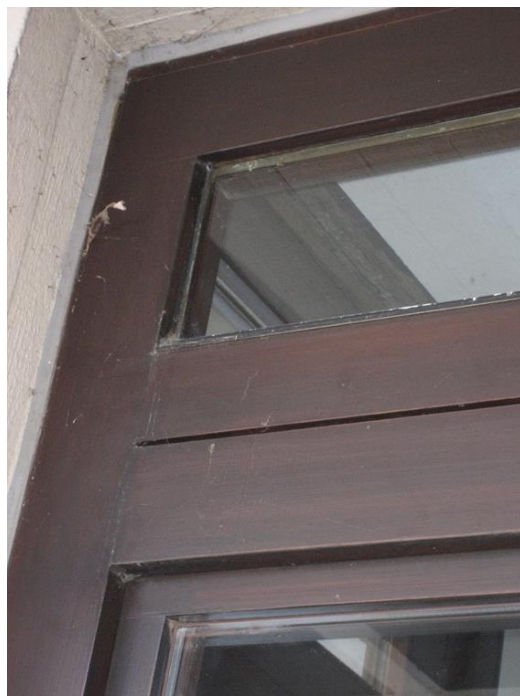
- In outdoor sealants in seams between concrete blocks.
- In indoor elastic sealant materials
- In elastic sealants around windows and door frames

Examples of PCBs in outdoor sealants between concrete blocks

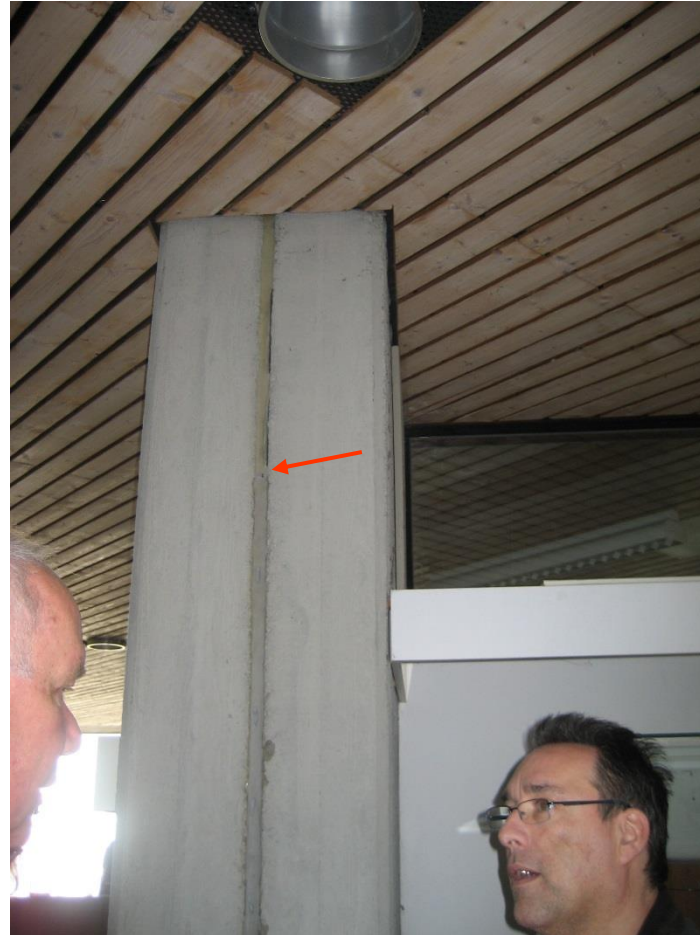
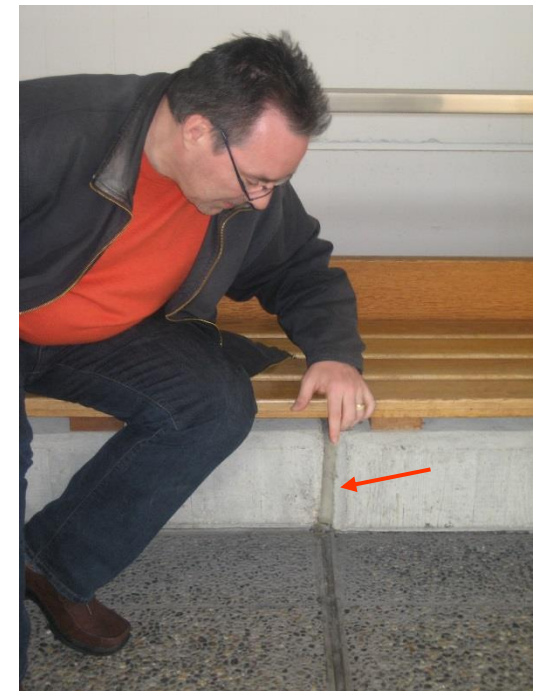
Examples of PCBs in indoor elastic sealant/caulk materials

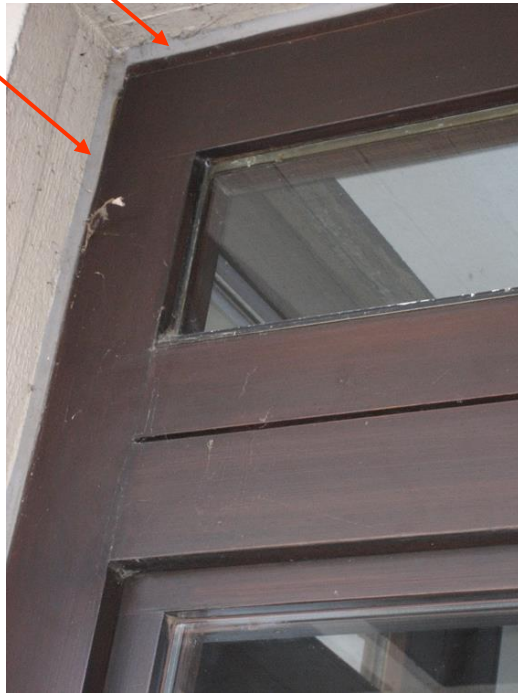
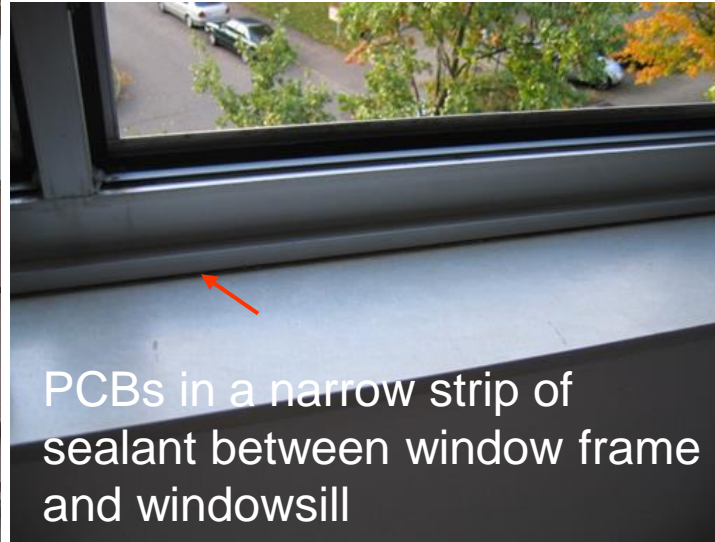
Examples of PCB-containing sealants around doors and window frames

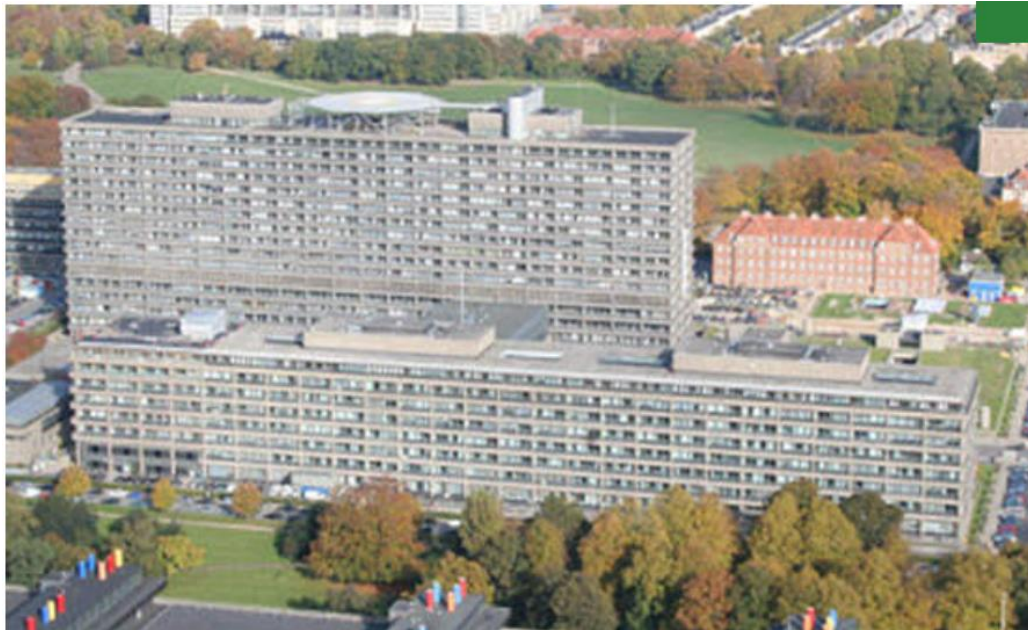
- In Copenhagen University Hospital some of the outside face joints and butyl seals between glass bead and window glass in the double glazing contained varying concentrations of PCB.

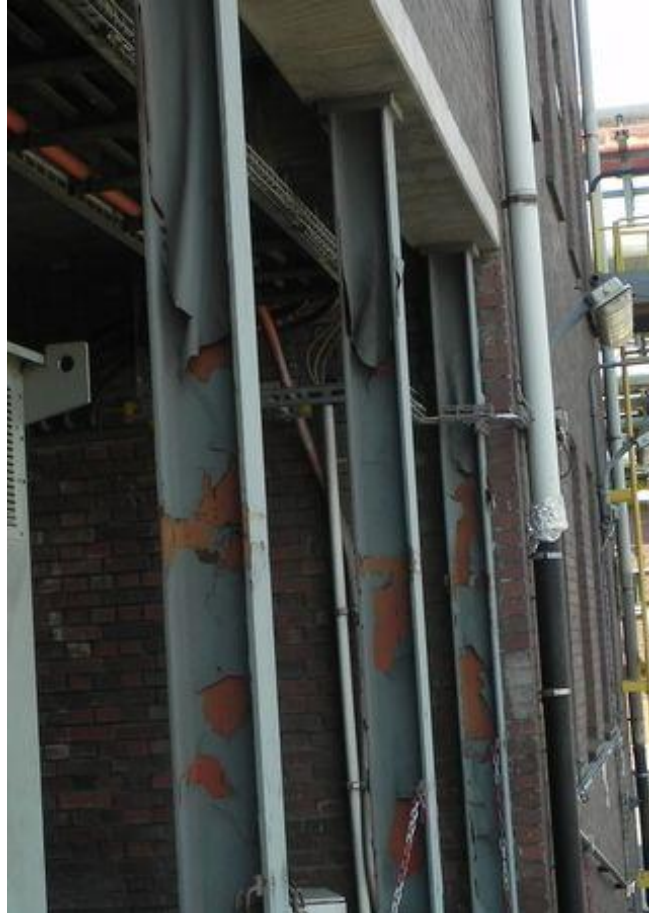
Flaking anti-corrosion paint

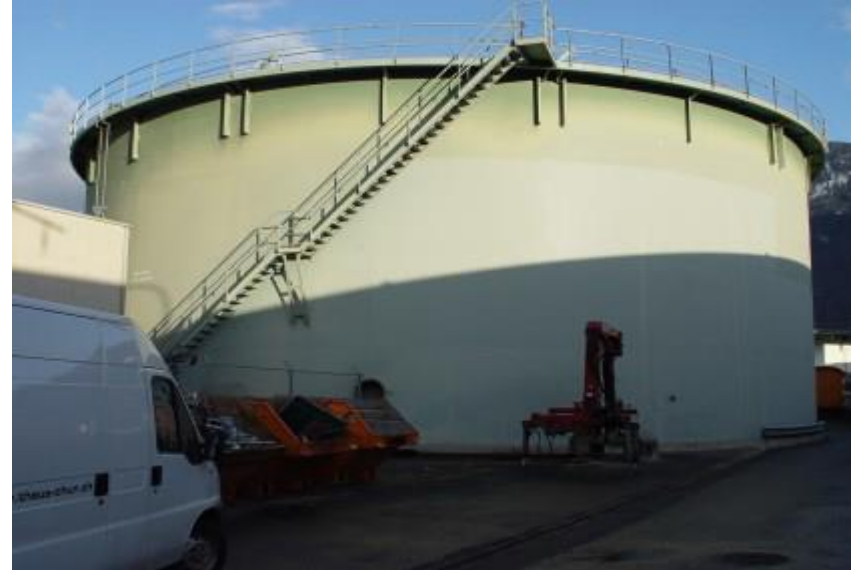
Tank, anti-corrosion coating

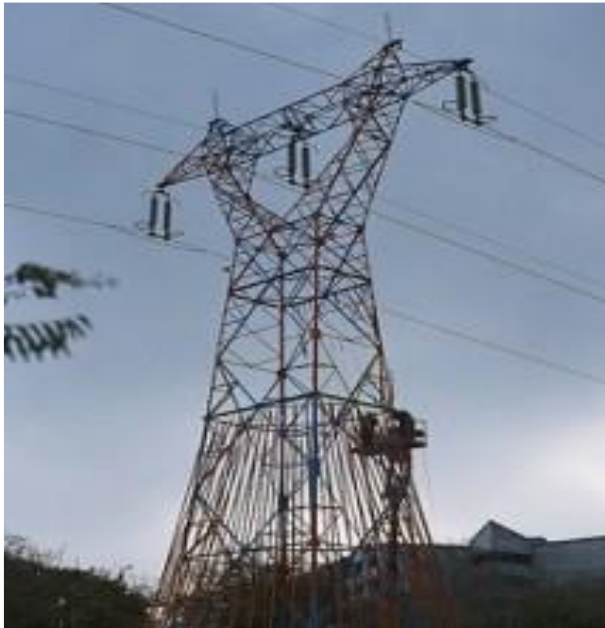
Pylons

- In a range of outdoor anti-corrosion applications PCB paints have been verified including (metal) **bridges** or pylons.
- The share of PCB paints in anti corrosion resistant paints on metal constructions (mainly chlorinated rubber and PVC-copolymer coatings) is not known. **Also alternative chlorinated organics were used (SCCP/MCCCP; PCNs)**
- For “dry” applications often heavy metal paints were used (lead, zinc).

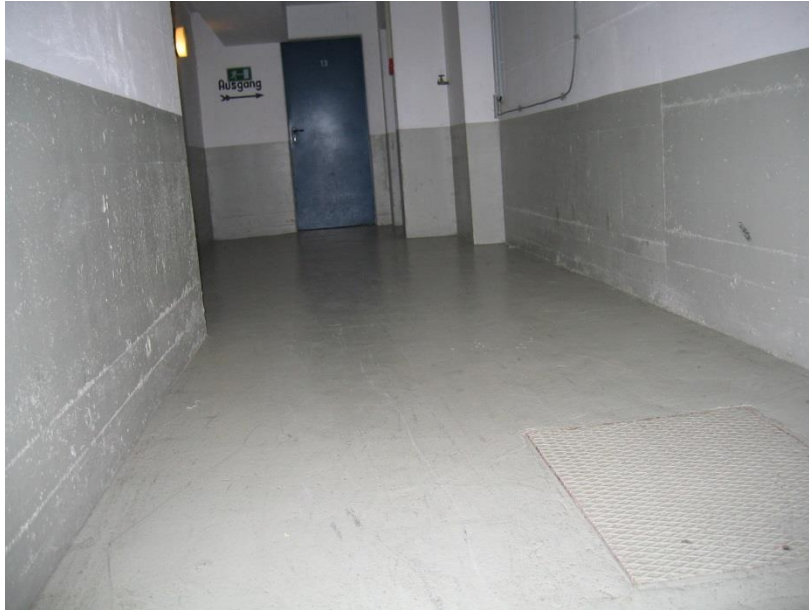
Paint in the basement of an apartment building
Paint on concrete (floor, walls),
paint on fire protection door

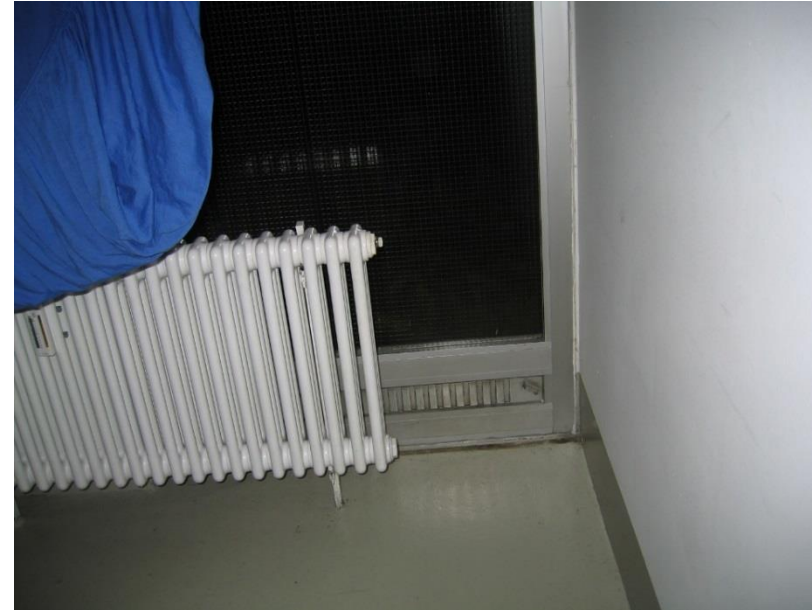
Paint in the laundry-room of an apartment building: Paint on screed (floor) and plaster (wall)

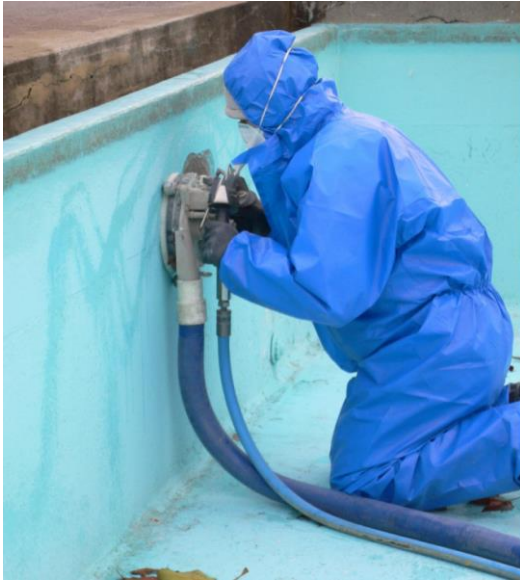
- Large use as coating in swimming pools.
- In Switzerland it is estimated that 20 % of outdoor swimming pools are contaminated.
- **Swiss inventory of swimming pools** developed by regional competent authorities.
- City Hannover/Germany screened their public pools for PCBs (inventory city level) and found some PCB contaminated.

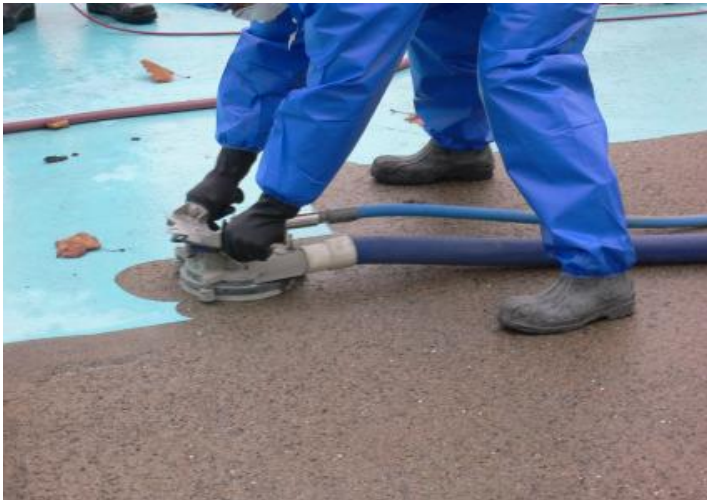
- Because of inappropriate handling during previous renovations the surrounding ground around swimming pools is sometimes contaminated above the PCB limit value for soil.

Removal of PCB-containing paint in a swimming pool in Zurich (Switzerland)

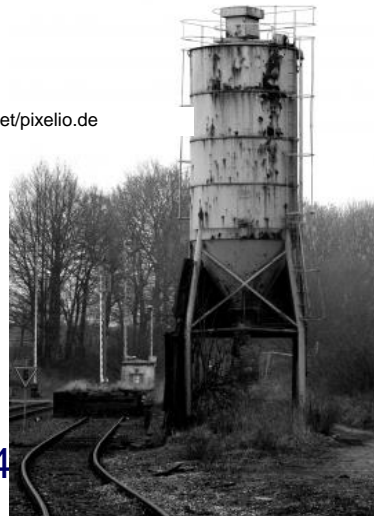
- PCB paints were used in silos as coatings to protect concrete/metal against acidic feed. This was the major source of PCB contamination of cow milk in Germany.
- PCB paint has been applied inside the barn and manure pit,
- This coating was one of materials in 50 to 70s strong enough to withstand gases arising from the manure (likely based on chlorinated rubber or PVC copolymer).
- The transfer of PCB in manure resulted in PCB contamination of agricultural areas.
- Also in this application substitution by chlorinated paraffins and probably

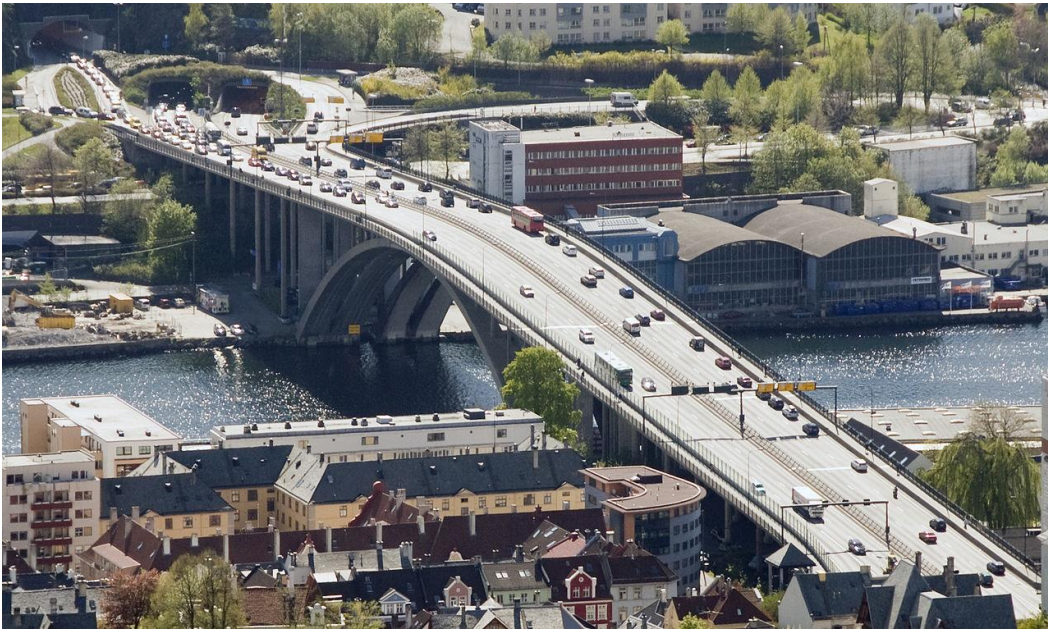
Puddefjordsbroen Bridge (Bergen, Norway)

- Bridge close to the Norwegian coast
- Concrete bridge covered with plaster and a layer of PCB-containing paint when built in 1956

- 11,000 m² painted surface area
- **Total amount of PCBs: 1650 kg PCB.**
- Completely sandblasted in the mid-1980s
- Marine sediments below the bridge are heavily contaminated with PCBs.

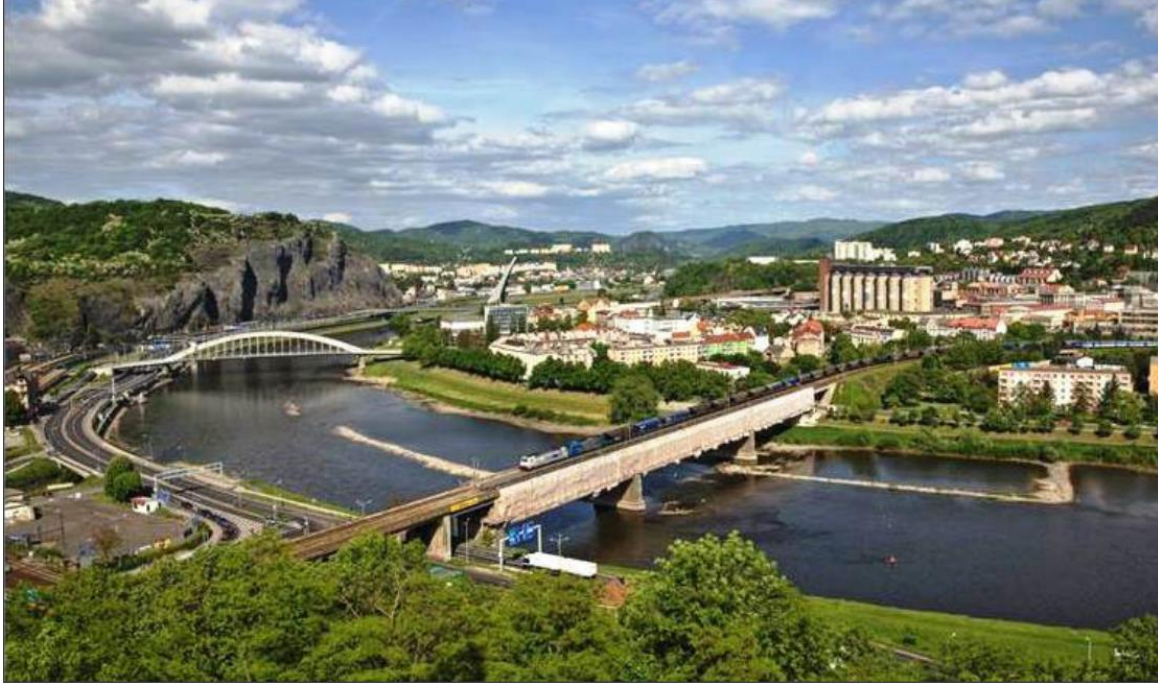
- PCB contamination of the river Elbe is monitored since the 1990s.
- In spring 2015 a railway bridge with anti-corrosive coating was renovated in a Czech city.
- Despite enclosure of the working area (photo) approx. 500 kg PCB (100 kg PCB₆) ended up in the river Elbe.

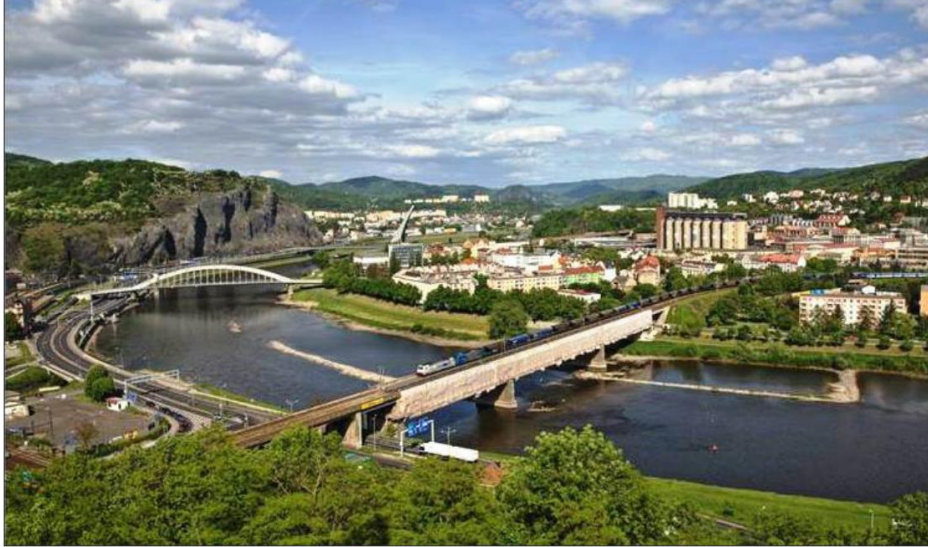
- PCB-contaminated sediments are moving towards the Port of Hamburg (distance of 500 km).
- Here every year ca 3 million cubic meters of sediments have to be removed from the waterway to secure access for seagoing vessels.
- PCB-contaminated sediments are not allowed to be dislocated.

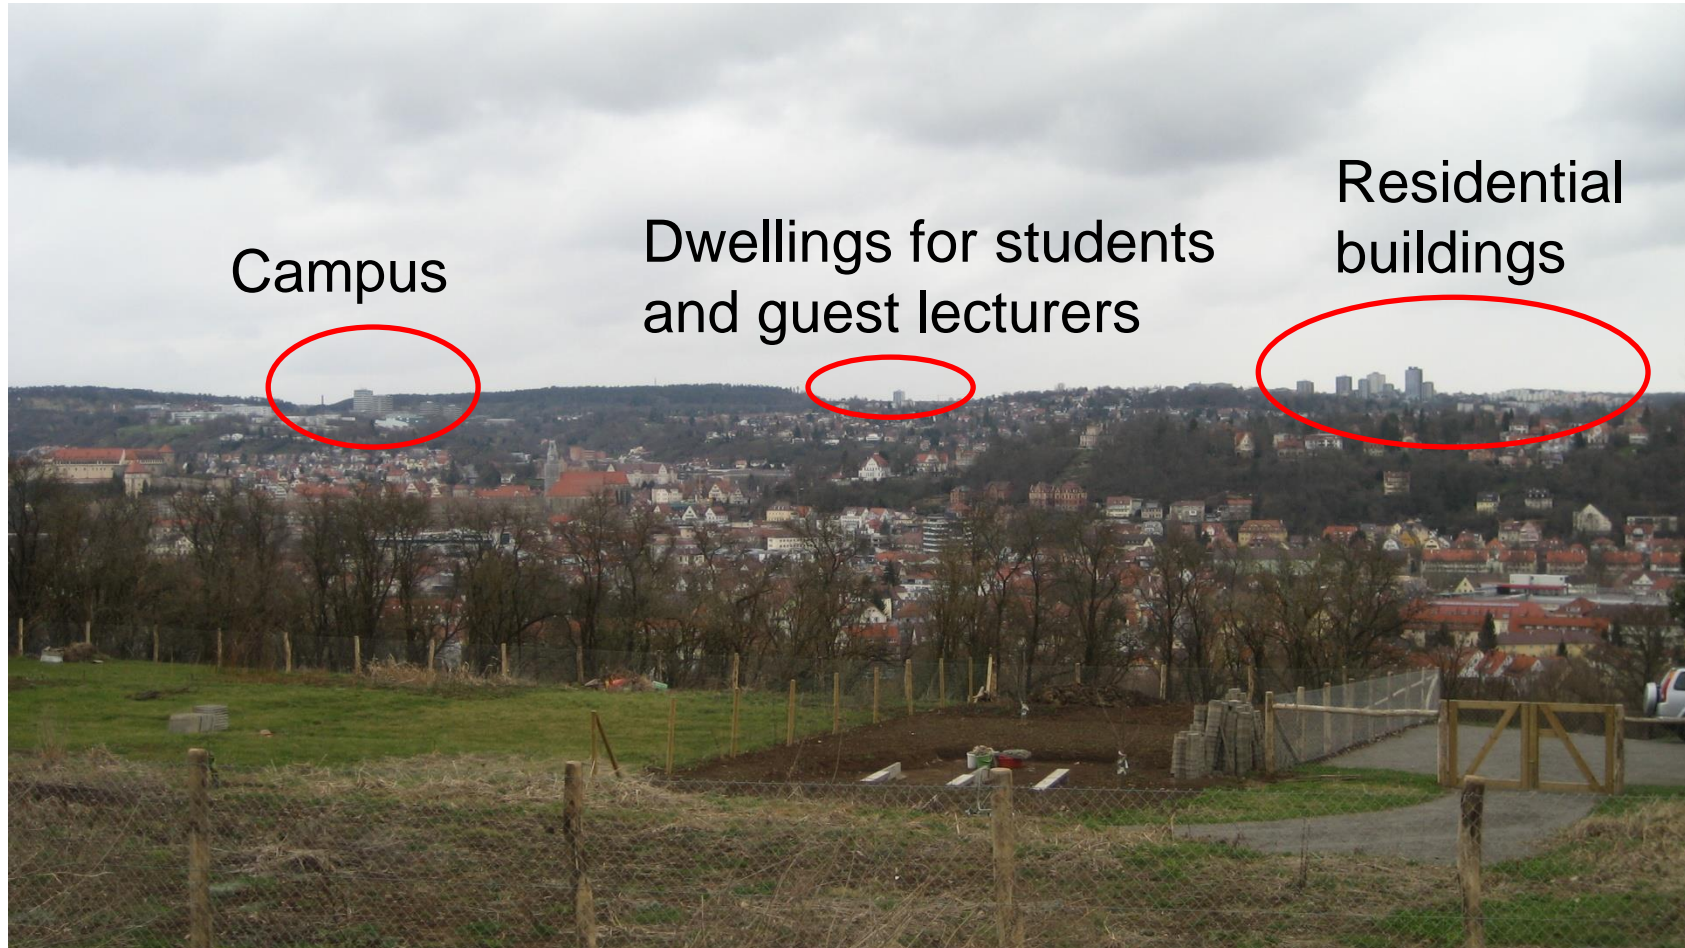
PCB emission source: PCB in sealants and ceiling tiles on the campus Morgenstelle of the University of Tuebingen

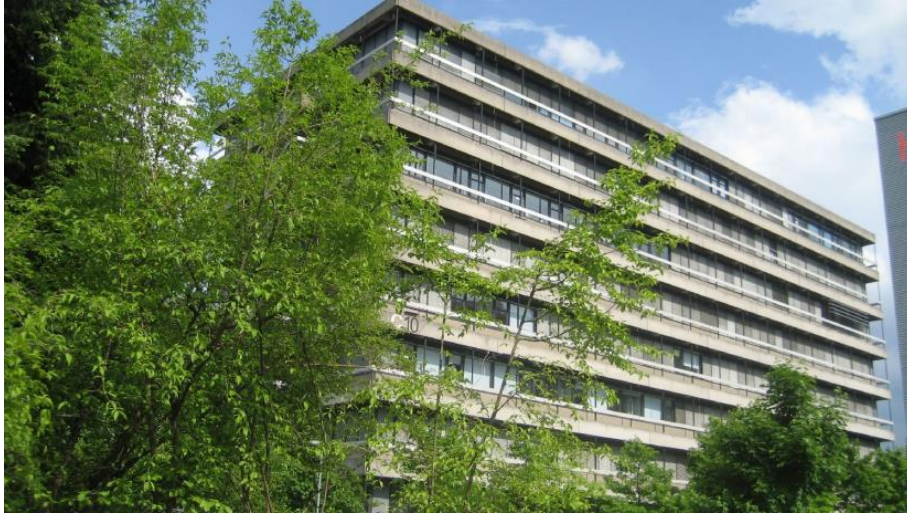
PCB abatement in building C (mathematics/physics)

PCB inventory of the building C, prior to PCB abatement in 2005/06:

More than 1 t PCBs in sealants, ceiling tiles and paint.

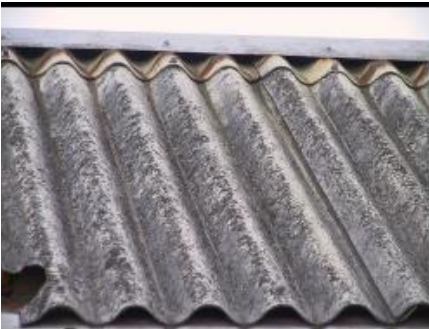
Germany: dl-PCBs in BIO eggs due to asbestos-cement fiber plates (ACP): Chemical and DR CALUX toxic dl-PCBs same!

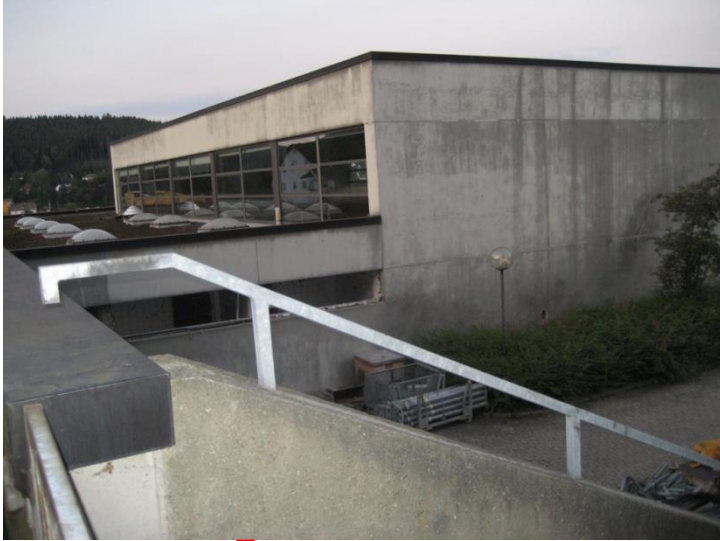
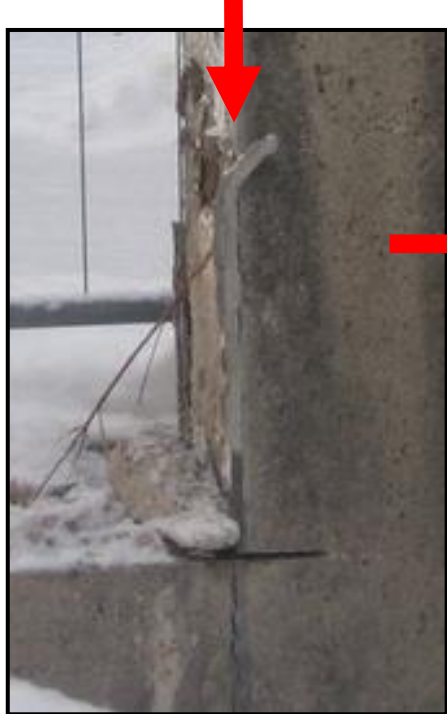
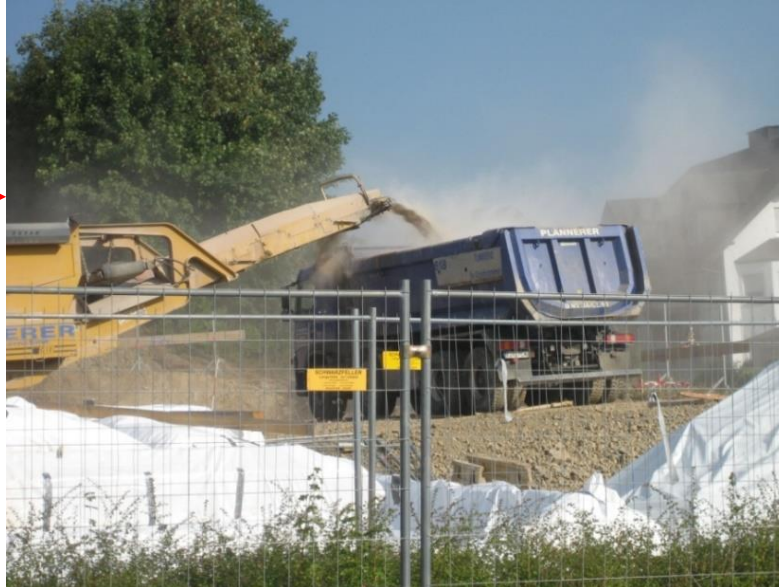
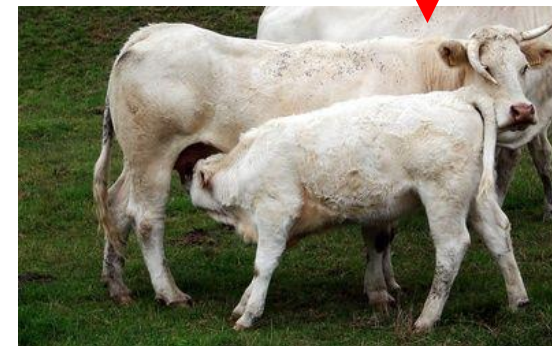
Monitoring POPs in C&D waste and recycling: PCBs

- PCB-sealants and paints can contaminate construction debris if not removed.
- Contamination of surroundings.
- Contamination of cattle when construction debris was used on farms for landscaping.
- **Recycling material is PCB-contaminated (PCB limit for recycling Germany 1 mg/kg Switzerland 0.5 mg/kg)**
